RIBBON SLATE

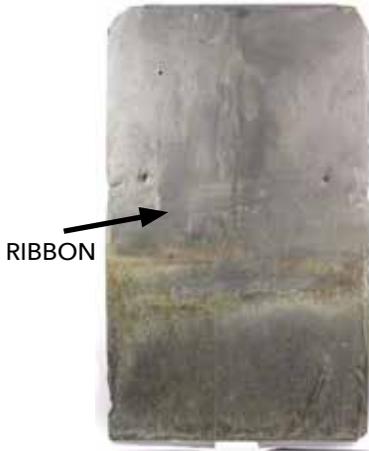
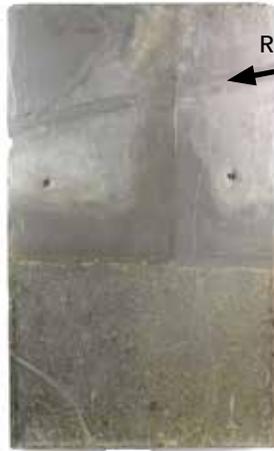
RIBBON SLATE

Ribbon slate is the name given to slate that has a distinct band of contrasting material running through it. The composition of the ribbon is similar to the surrounding material, but with an excess of Magnesium and Calcium Carbonates, a sedimentary layer of the original bedding. It is more susceptible to weathering and has a high rate of water absorption. This is most commonly found in Penn Black slate, quarried from the Lehigh valley in Pennsylvania.

Theoretically, during the quarrying process, sections of the slate bed displaying ribbons are cut out and thrown on the rubbish pile. However, when this produces an egregious amount of waste they are used to produce a second-tier quality of slate. Slate split from a block are holed and trimmed in such a manner that the ribbon occurs on the top end of the slate, thus hidden from view once they are installed on a roof.

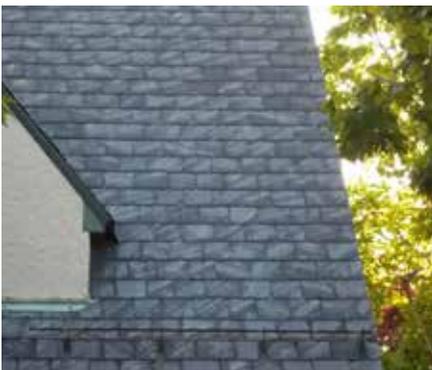
CHAPMAN SLATE

It is not to be confused with Chapman slate, colloquially referred to as Ribbon Slate and quarried from the same area, or Strata slate from Vermont. Both Chapman and Strata have striations across the slate, but these are largely quartz and carbonaceous deposits, as hard or harder materials than the slate itself.

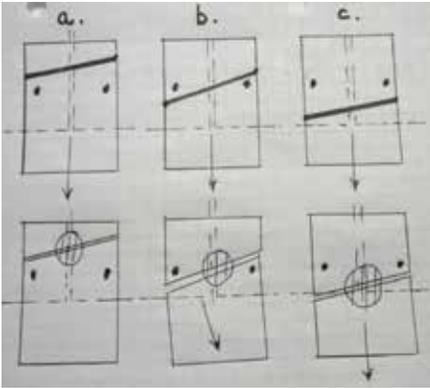
Once it deteriorates the ribbon leaves a gap through which water can penetrate.

a. There is no movement of the exposed slate when the ribbon is above the nail holes. If the ribbon is beneath the head-lap, however, a leak will occur as shown. These leaks are the hardest to locate.

b. A ribbon between the nail holes may cause the slate to skew to the side but the exposed section is still held in place by one nail. Again a leak will occur.

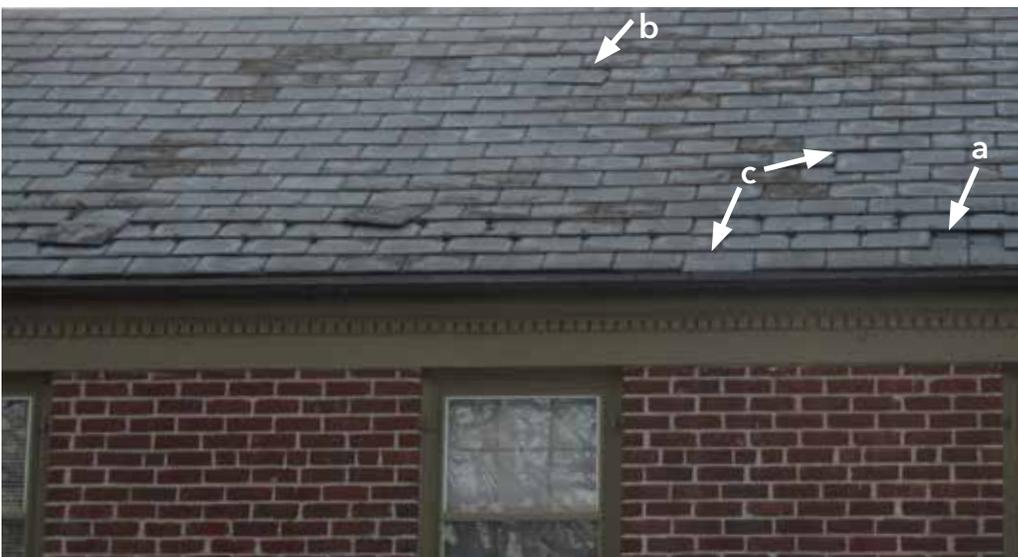
c. Once the ribbon disintegrates below the nail holes, the lower half of the slate will work loose and the largest area will be exposed to leaking.

a roof with a handful of breakages that appears an easy repair. The slater, with a little investigation, discovers the roof is made up of ribbon slate. Once the ribbons have disintegrated and slate are shedding, one can be assured that hundreds of slate in the roof are on the point of shedding. The slightest impact will precipitate breakage and a ten slate repair rapidly becomes a twenty or thirty slate repair. More importantly, while work performed and money spent may correct specific leaks, in the larger picture both are losing propositions. At this point it is often the underlayment paper alone that protects the home interior from water damage, and unfortunately the only solution is to replace the roof. Ribbon slate was always a low quality product and using them a bad idea. Finally it is catching up with us.
